Every time it rained, the ground fault circuit interrupter on our 15-KW tactical quiet generators (TQG) would trip.

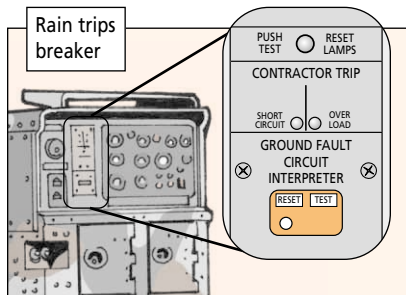
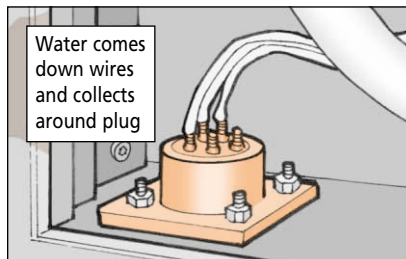
The problem was the J16 plug located on the bottom of the output box assembly, just below the voltage reconnection panel. When the door to this compartment is bent, when it has a worn seal or does not close properly, water leaks and collects around the J16 plug.

It doesn't take much moisture to short out the input wires.

Fine job, Specialist. This is also a problem on the 30- and 60-KW generators. CECOM is aware of this. New production generators will have heat shrink around the J16 plug wires and should solve the problem. RTV is fine for those generators in the field with the problem. Just make sure the RTV fully covers the electrical wires from the wire insulation to the J16 connector.

I solved the problem by insulating the plug with RTV.

First, make sure the plug is *completely* dry. Then apply the RTV at the top of the plug where the wires are exposed.

Also, replace the seal on the access door to the compartment or get a new door if the old one won't close.
